Thomas J. Dixon House

Marion vicinity

Maryland Historical Trust
State Historic Sites Inventory Form

Survey No. S-261

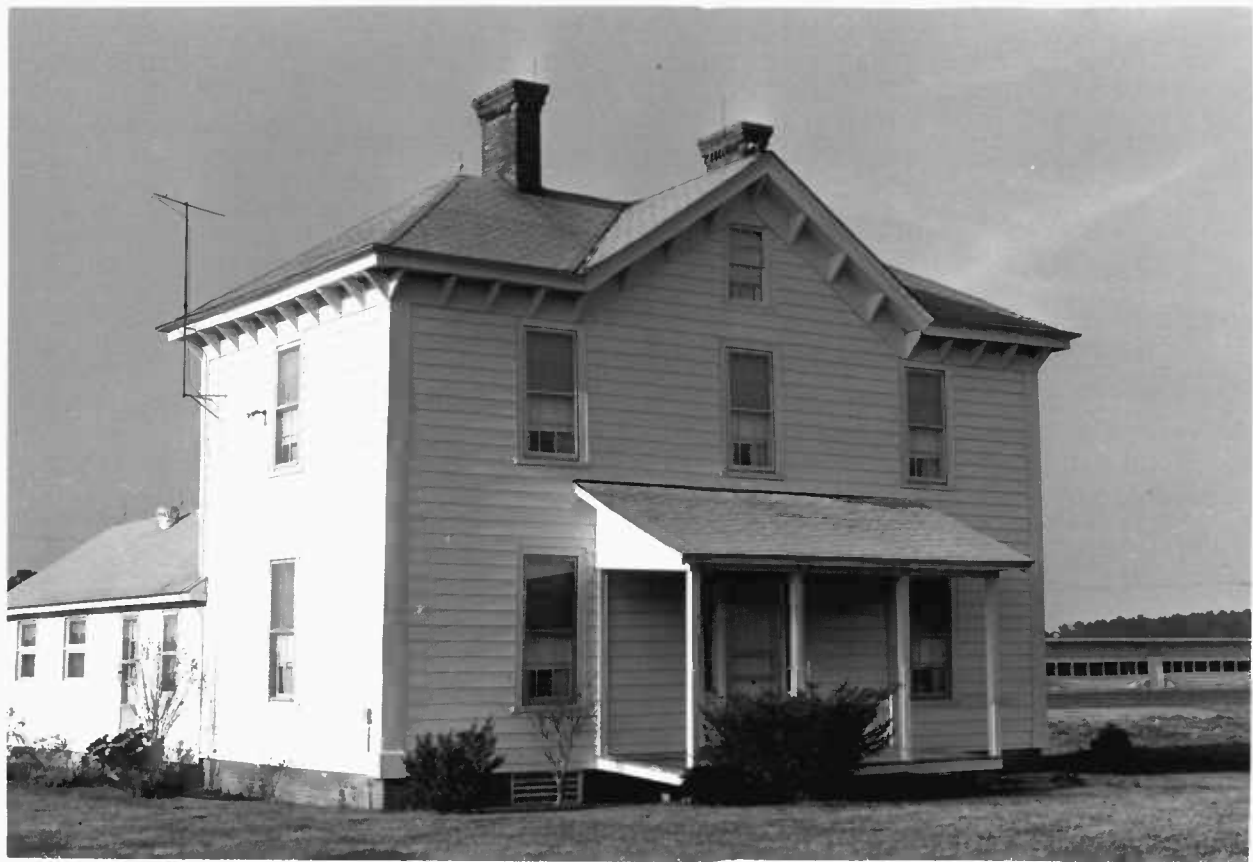
Thomas Dixon House S-261
Near Marion, Somerset County
East Elevation
10/84, Paul Touart
Neg./MD Historical Trust

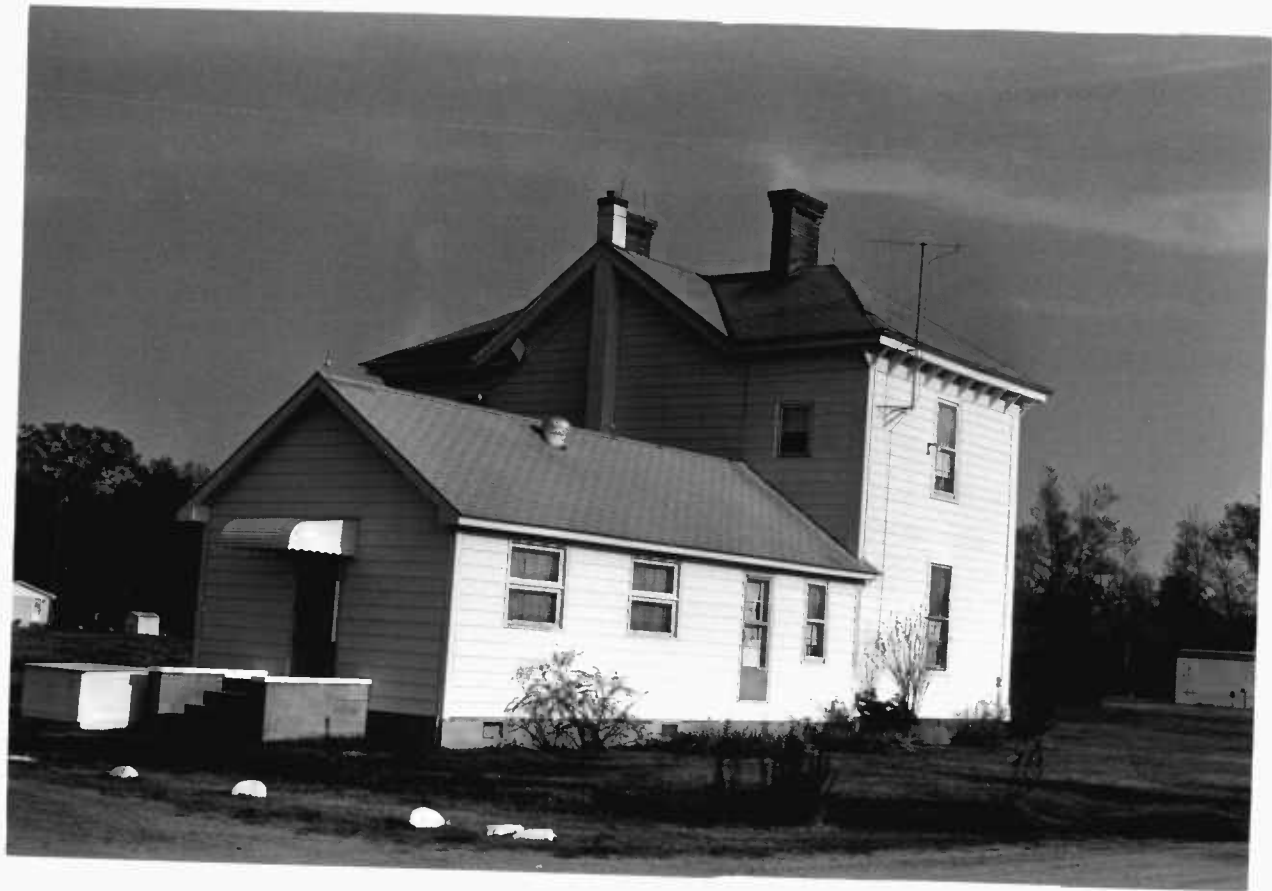
Thomas Dixon House S-261
Southwest Elevation
Near Marion, Somerset County
10/84, Paul Touart, Photographer
Neg./MD Historical Trust
